Pedestrian Study

Qualitative Assessment
Pedestrian Volume Count

SR 15/600 (US 17/92)
Between Catalina Drive and Debarry Drive

VOLUSIA COUNTY
SECTION 79040
MP 2.912 to MP 2.968

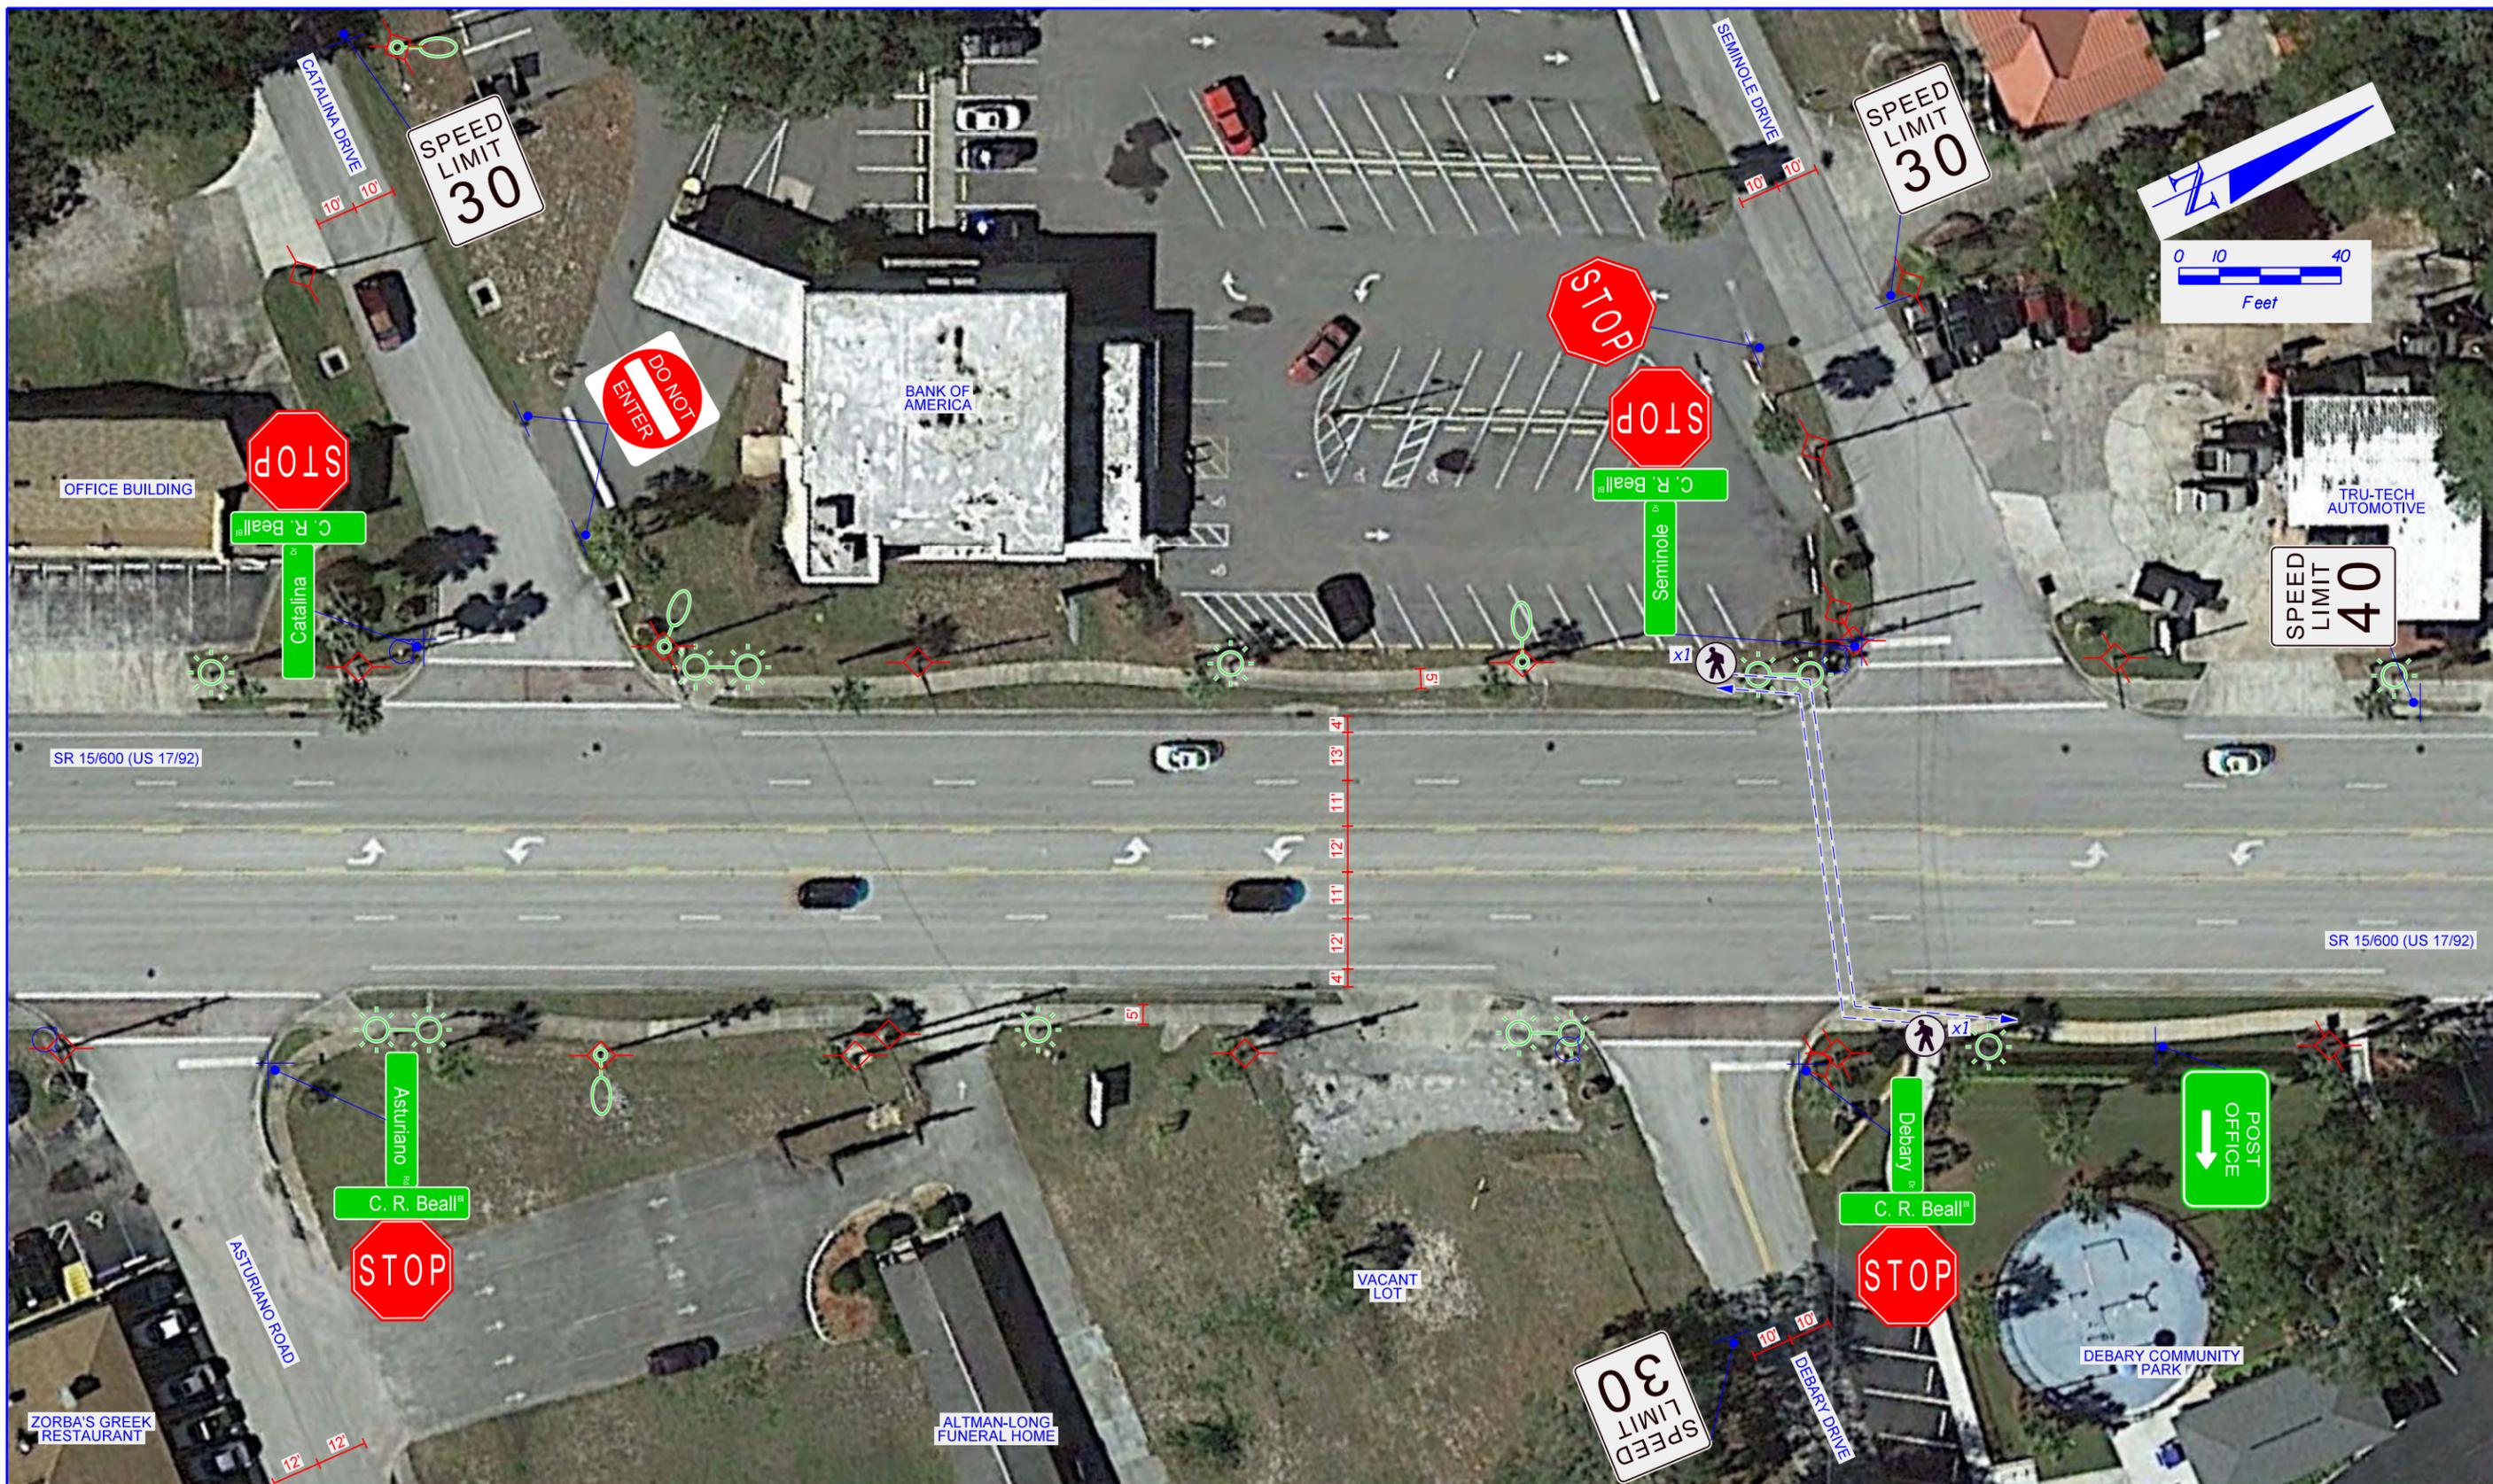
Four-hour pedestrian/bicycle count summaries are included in the appendix of the report. The pedestrian/bicycle crossing locations are shown in detail in Figure 2.

- Both of the pedestrians that crossed US 17/92 during the pedestrian count completed their movement at Debary Drive. The pedestrians crossed utilizing the curb ramps on the north side of Debary Drive and the south side of Seminole Drive. No conflicts were observed with these crossings.

- One pedestrian crossing occurred between 11:30 and 11:45 AM and originated on the west side of US 17/92 at Catalina Drive. After crossing, the pedestrian continued north along the east side of US 17/92 to the bus stop.

- One pedestrian crossing occurred between 1:30 and 1:45 PM and originated on the east side of US 17/92, north of the study section. After crossing, the pedestrian continued south along the west side of US 17/92.

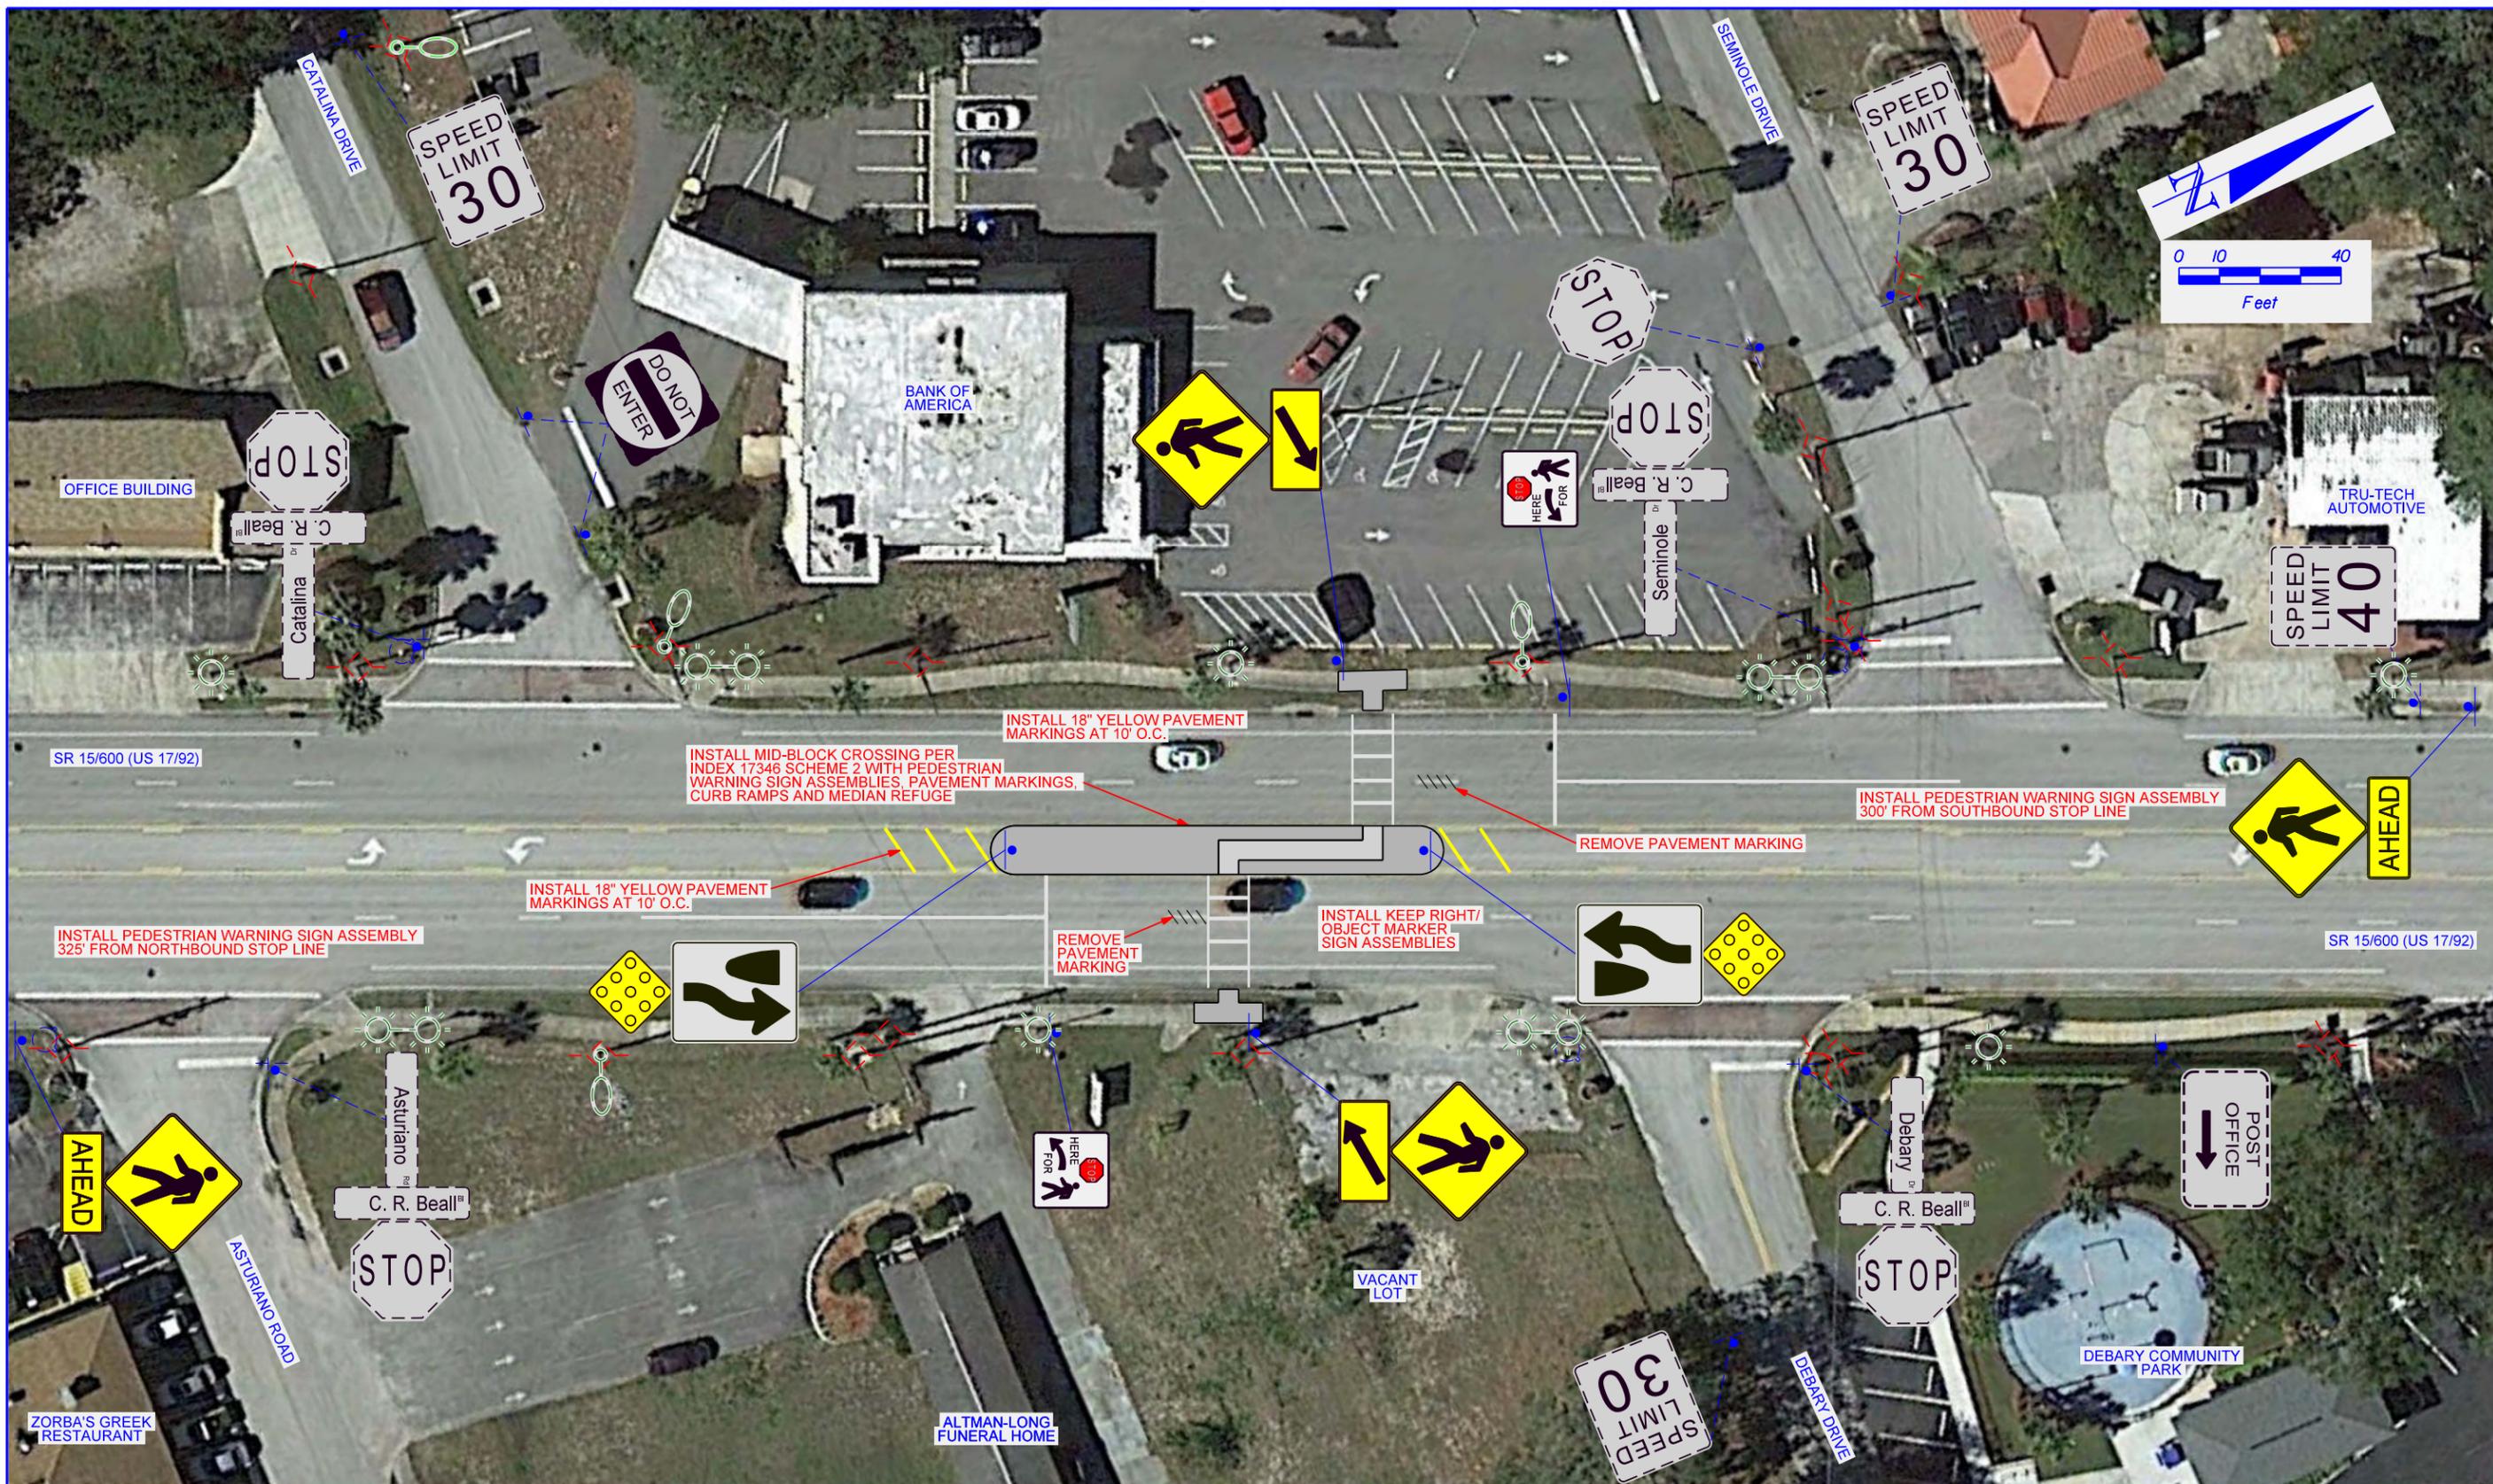
FIGURE 3
 CONCEPTUAL IMPROVEMENT DIAGRAM
 DISTRICTWIDE COMMUNITY
 TRAFFIC SAFETY PROGRAM

A conceptual improvement diagram has been developed to further depict the recommended improvements and is included on the following page.

1. A mid-block crosswalk should be installed between Catalina Drive and Debary Drive.
 - a. Install crosswalk signing and pavement markings per Index 17346, Sheet 10, Scheme 2.
 - b. Construct curb ramps to accommodate the installation of the mid-block crossing.
 - c. Construct a pedestrian refuge island within the two-way left turn lane.
 - d. Install KEEP RIGHT/Object Marker sign assemblies on the north and south ends of the pedestrian refuge island.

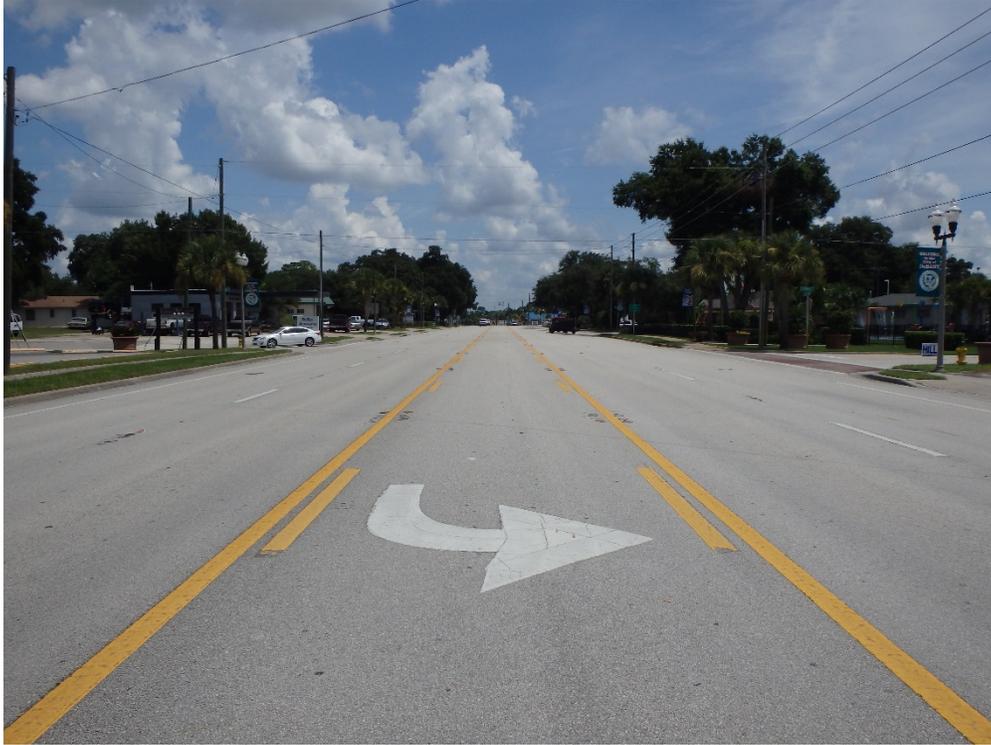
Looking north along US 17/92 within the project corridor

- US 17/92 is a four lane arterial roadway divided by a painted median within the study limits. The alignment within the study corridor is straight and level.

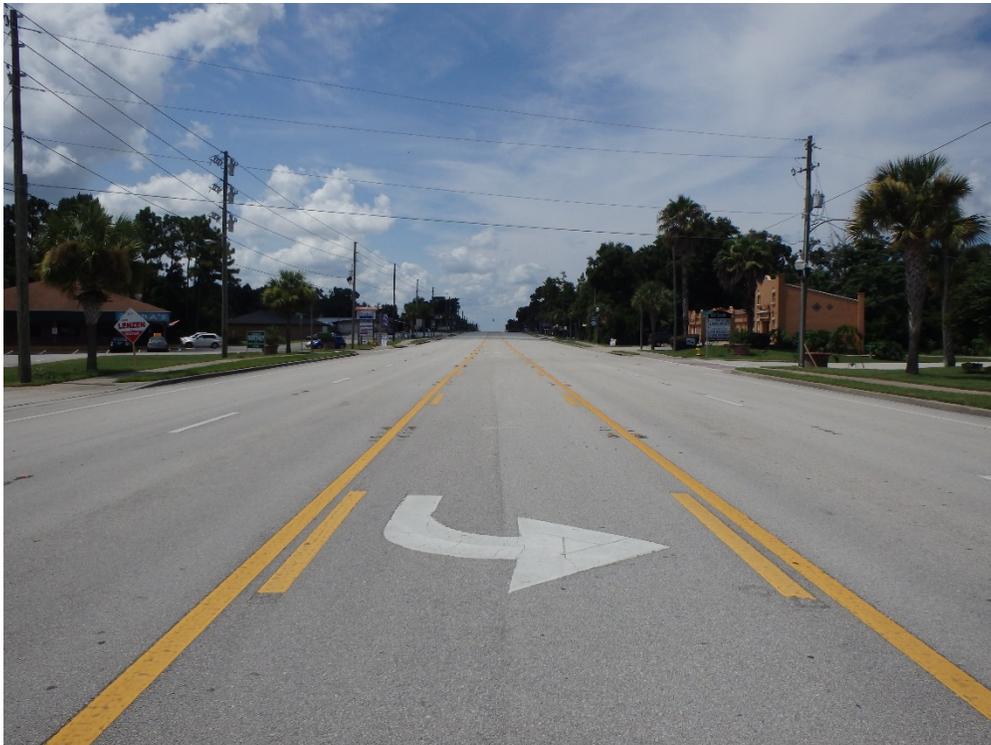
Looking south along US 17/92 within the project corridor

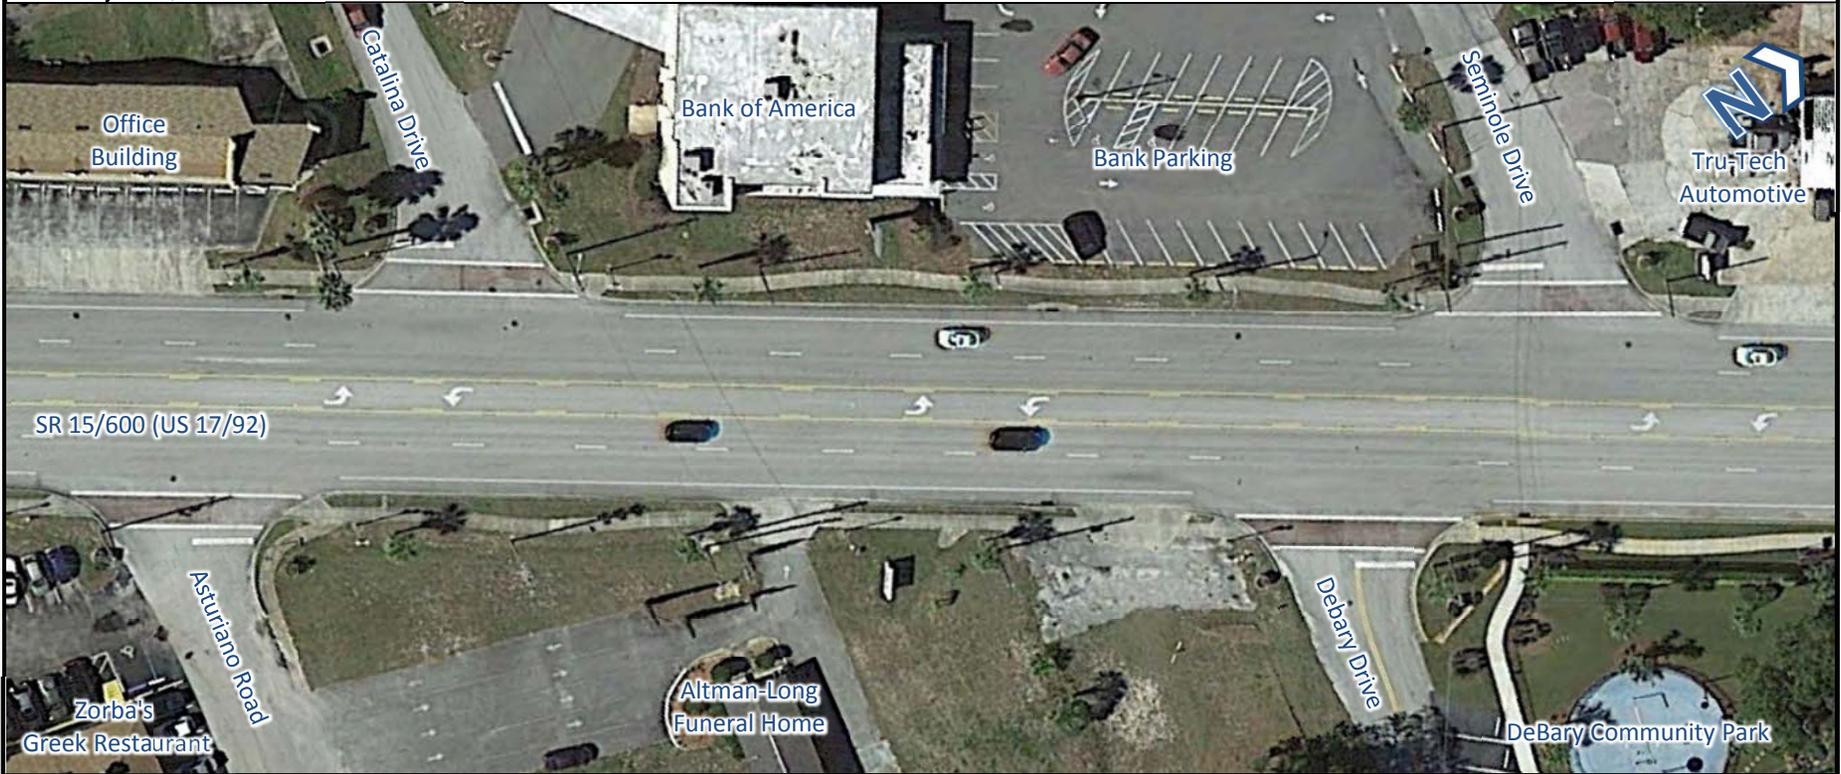
From MP 2.912 to MP 2.968

Pedestrian/Bicycle Movement Summary
 Section: 79040
 Mile Post: From 2.912 to 2.968
 Date: July 25th, 2014

State Road: SR 15/600 (US 17/92)
 Observer: KLC
 Time: 11:00 AM-3:00 PM
 Weather: Fair
